DEPARTMENT OF TRANSPORTATION

Quality Assurance and Source Inspection

Contract #: 04-0120F4Cty: SF/ALA Rte: 80 PM: 13.2/13.9File #: 69.28**WELDING INSPECTION REPORT****Resident Engineer:**Siegenthaler, Peter**Address:** 333 Burma Road**City:** Oakland, CA 94607**Report No:** WIR-024029**Date Inspected:** 16-May-2011**Project Name:** SAS Superstructure**OSM Arrival Time:** 1500**Prime Contractor:** American Bridge/Fluor Enterprises, a JV**OSM Departure Time:** 300**Contractor:** Zhenhua Port Machinery Company, Ltd (ZPMC), Changxing Island **Location:** Shanghai, China**CWI Name:** Mr. Li Yan Hua**CWI Present:** Yes No**Inspected CWI report:** Yes No N/A**Rod Oven in Use:** Yes No N/A**Electrode to specification:** Yes No N/A**Weld Procedures Followed:** Yes No N/A**Qualified Welders:** Yes No N/A**Verified Joint Fit-up:** Yes No N/A**Approved Drawings:** Yes No N/A**Approved WPS:** Yes No N/A**Delayed / Cancelled:** Yes No N/A**Bridge No:** 34-0006**Component:** OBG**Summary of Items Observed:**

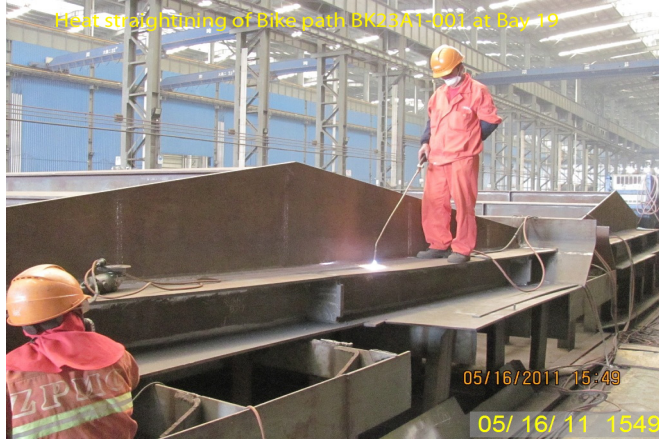
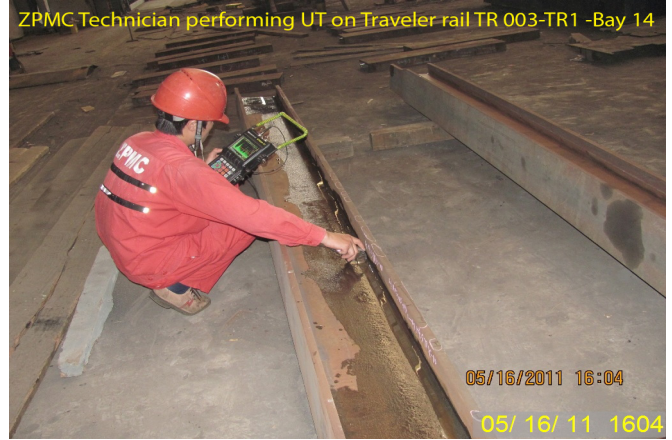
Heat Straightening being performed on Bike Path identified as BK023A1 – 001-25 to 34 by oxy-acetylene flame method to remove the distortion that occurred after welding. ZPMC Quality Control (QC) Inspector is identified as Li Ping present at the location. This activity appeared to comply with the Heat Straightening Report # HSR1 (B) – 10364. (See photo)

For further information see below pictures:-
